Excursion Report
Transylvania - Romania, July 2018

Author & Photographs: Lukas Valentin Flandorfer
TU Wien

Study tour report
12th of July, 2018 - Dealu Frumos

Experience report - Hands on workshop
16th - 20th of July, 2018 - Daia/Denndorf

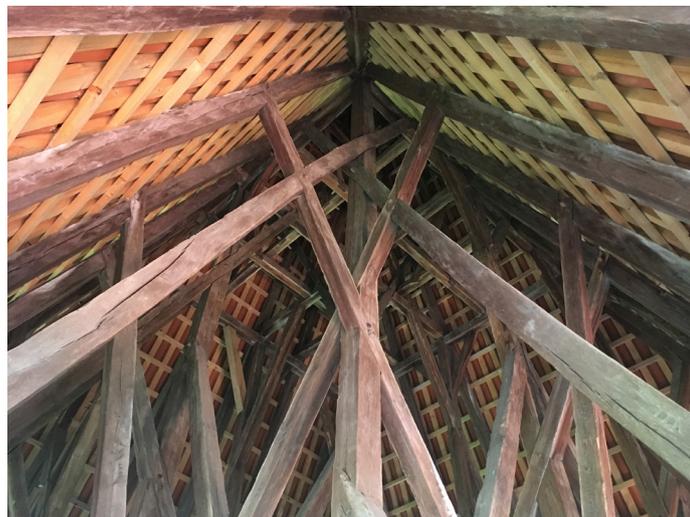
Timber Construction of the church tower

The 12th of July we fully spent in Dealu Frumos and it gave some very interesting insights about the restoration of fortified churches but also daily life in the village. The architect, Liviu Gli-gor, in charge of the restoration of the fortified church in Dealu Frumos guided us through the church and up to the tower where he described the restoration of the wooden construction, how to deal with different damages and problems which occurred during the restoration in terms of finding the right partners, compromises and craftsmen but also in finding the right materials.

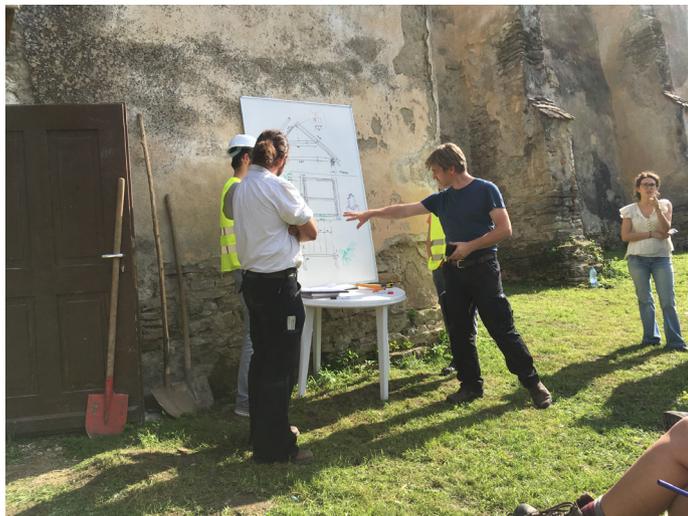
Reconstructing the barn

stories we got a feeling of what would expect us in the upcoming days. While originally it was planned to restore a barn next to the church by replacing damaged elements, plans changed when this barn collapsed one week before our arrival. On the site of the barn there were now just loose tiles and bricks piling between the crushed wooden construction. As a first task we split up in teams and tried to reconstruct the building by measuring all constructive parts and drawing sketches of the former shed. After we discussed the results and checking all evidence again we started by cleaning the site and collecting all intact tiles, bricks and usable wooden parts.

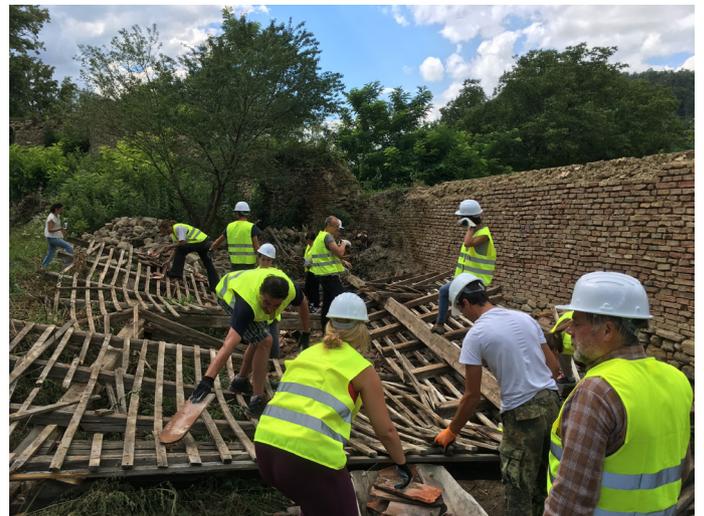
Cleaning the site

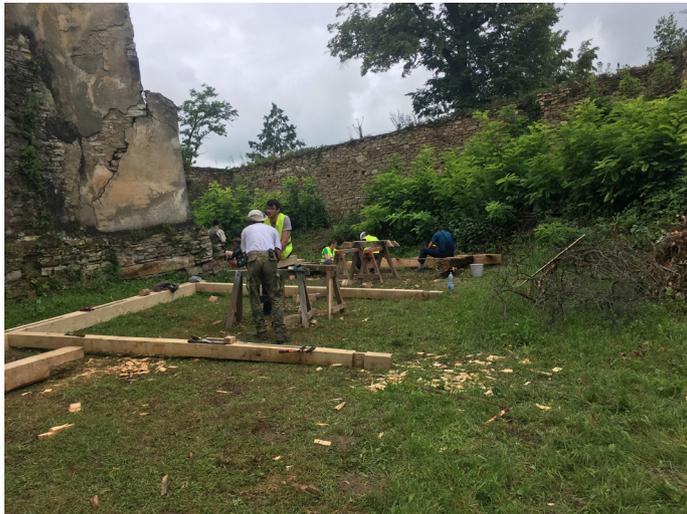
Creating timber joints

On the following days we analyzed the broken posts and beams and how to repair them by patching with new wooden beams. We learned

all about timber joints in another unit, planning to use dovetail connections and lap joints (Gerberstoß) among some others as these were the ones also used before. The analysis also contained the search for damages by water and insects to remove those parts. After a lot of measuring and trial and error to find the ideal cut lines to save as much original material as possible we started sawing, cutting and chopping the wooden beams to receive some traditional carpenter joints. There were some complications and unexpected damages and it took us a lot of time to produce all the joints as well as a lot of treenails necessary for holding them together. Working with all the tools such as chisel, crowbar, mortise ax, japanese saw, and carpenters square was challenging and exhausting at first but even more amazing once the right technique was found.

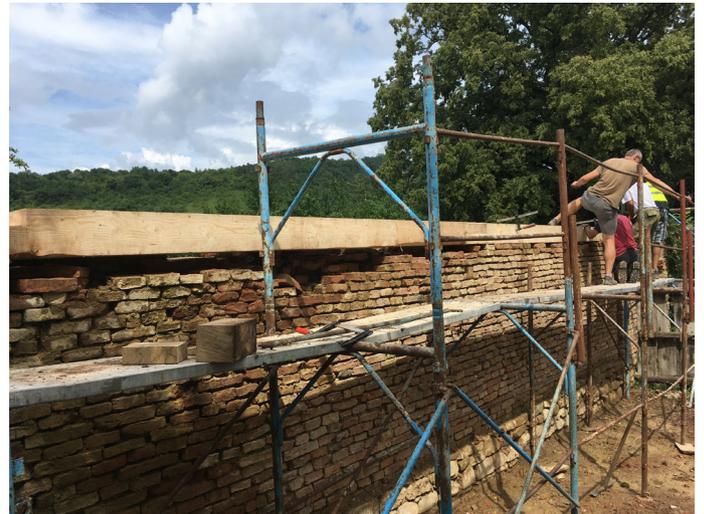
Placing the beam

At the end of the five days the construction was not erected but ready for it. As a last step we lifted the heaviest beam up on the wall and prepared everything for the following week, where some of this week's team were joined by some new team members to continue with the restoration of the barn.
